Thermal imaging cameras monitor overhead lines in Delhi metro railways

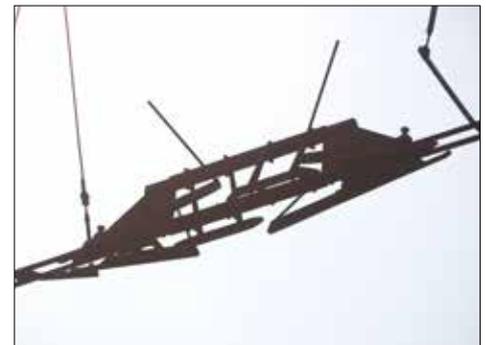
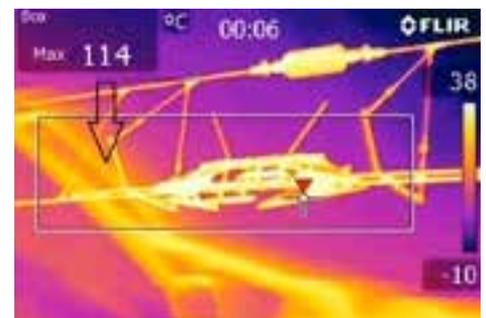
Early detection of rises in temperature helps DMRC to prevent costly failures and downtime.

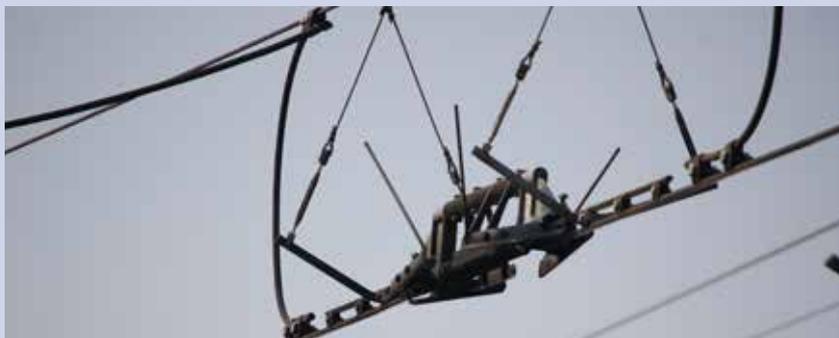
Section insulators are used on the overhead lines system (catenary structure) of railways to electrically isolate and separate sections for maintenance without having to turn off the entire system. The overhead line system is broken into electrically separated portions known as sections. Section insulators are also used extensively on change overs and can be used in conjunction to isolate sections in separate phases being fed by different feeder substations.

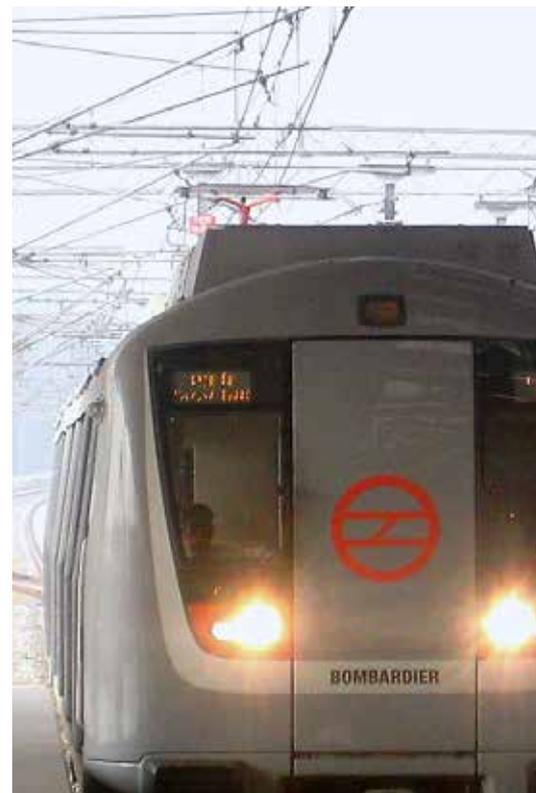
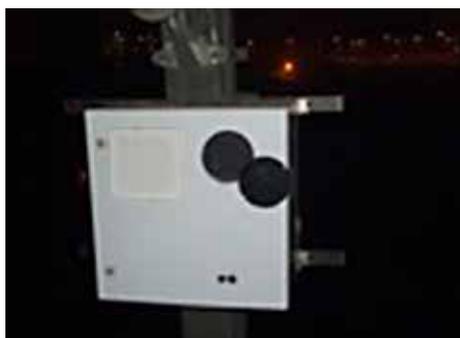
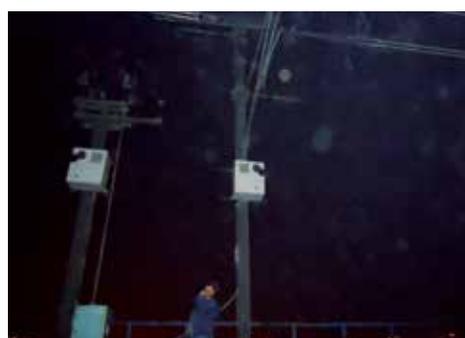
The FLIR E50 thermal imaging camera is installed in an IP66 rated enclosure.

When recently problems occurred in the metro railway network, which caused huge delays, DMRC suspected the problem was caused by the section insulators. The DMRC maintenance crew therefore installed one of their FLIR E50 thermal imaging cameras in an IP66 rated protective enclosure with Germanium infrared window to monitor the problematic section for an entire work day. Protected from adverse weather conditions by the protective enclosure the FLIR E50 thermal imaging camera was able to safely record the infrared radiation emitted by the section insulators and provide thermal
