Automatic quality controls with FLIR A320 ensure that the cars produced at Ford Genk work perfectly

FLIR A-Series thermal imaging cameras: accurate, reliable and maintenance free

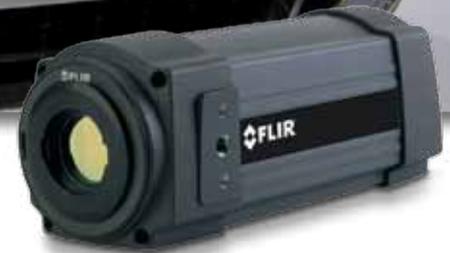
The FLIR A320 is an affordable and accurate non-contact temperature imaging and measurement tool.

The thermal imaging camera Arthur Knuyesen has chosen to perform these quality tests is the FLIR A320. The FLIR A320 thermal imaging camera offers an affordable and accurate temperature measurement solution with clever built in features like analysis, alarm functionality and autonomous communication using standard protocols. The FLIR A320 camera also has all necessary features and functions to build distributed single- or multi-camera solutions utilizing standard Ethernet hardware and software protocols.

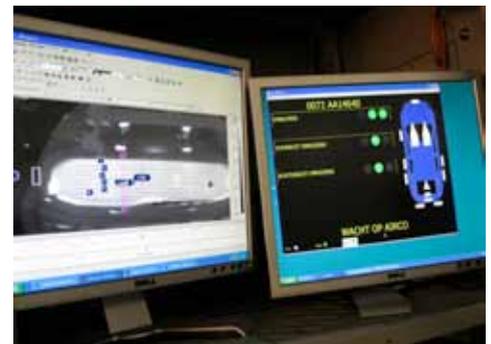
The programmable logic controller (PLC) compares the measurement data from the thermal imaging cameras with previously defined parameters.

The measurement data collected by the thermal imaging cameras are sent to the programmable logic controller (PLC), which compares the measured temperatures to previously determined parameters. If the recorded data is within those parameters then the car gets the green light to proceed. A screen next to the test site will display either a red or a green sign. If a red sign is shown the car must go to the repair department. If it is green the car can proceed to the next step in the testing range.

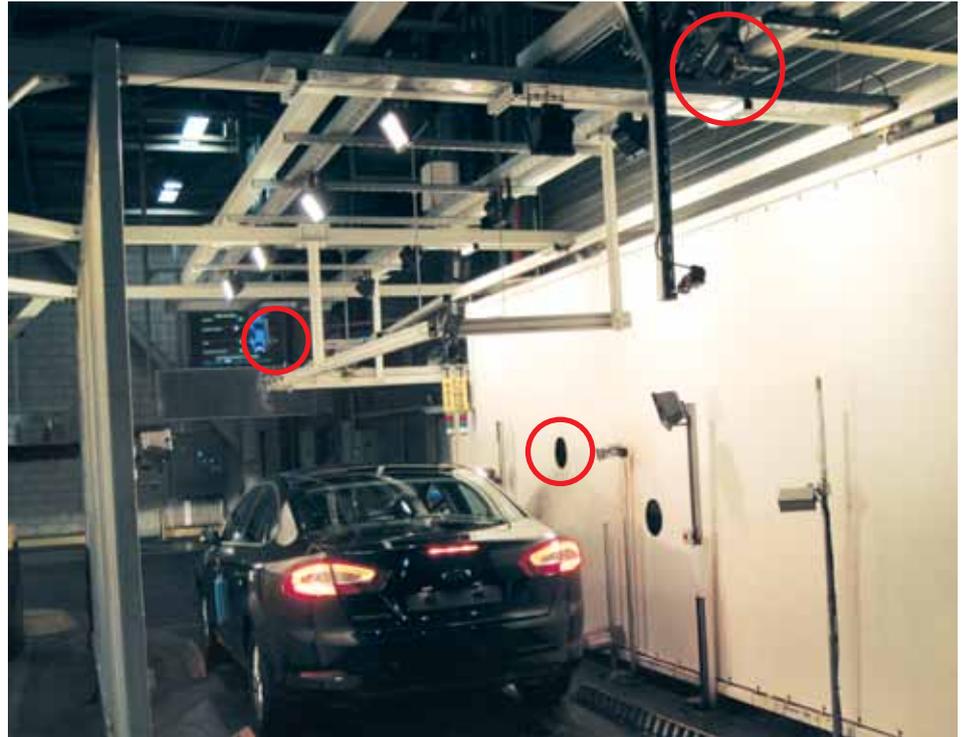
Ford Genk has three FLIR A320 thermal imaging cameras for testing the front window heating system, the rear window heating system and the air conditioning system. The locations of the thermal imaging cameras are marked in red.

temperatures of front window heating elements, rear window heating elements and the air conditioning vent outlet”, explains Knuyesen. “There’s one mounted in the front of the car, pointed at the front window, another mounted behind the car to monitor the rear view window and the third is pointed at the window of the car door at the right hand side, to measure the temperature of the air conditioning vent output.”

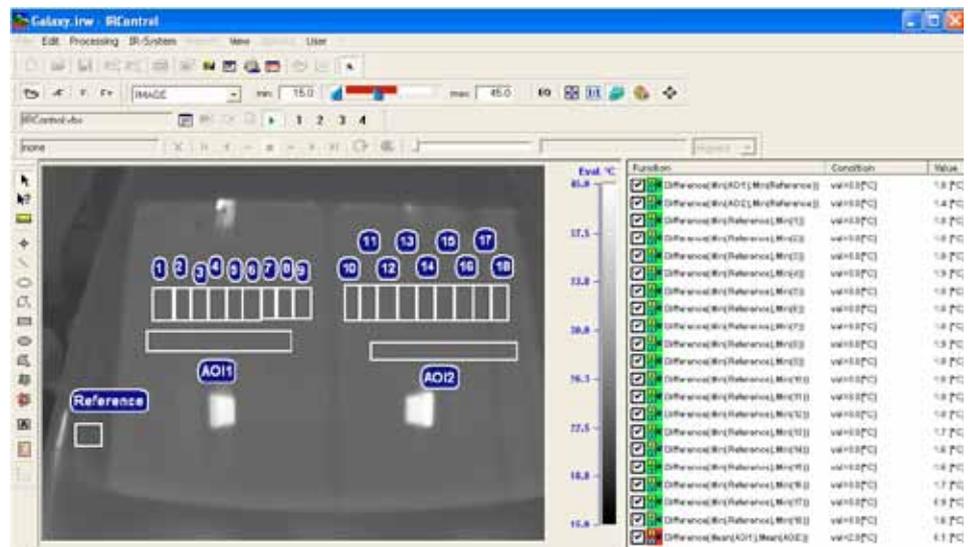
The control system Rato supplied for the rear window cannot be used here. Instead, the FLIR A320 records the maximum and minimum temperatures within the designated squares and the PLC compares these readings with previously determined parameters.

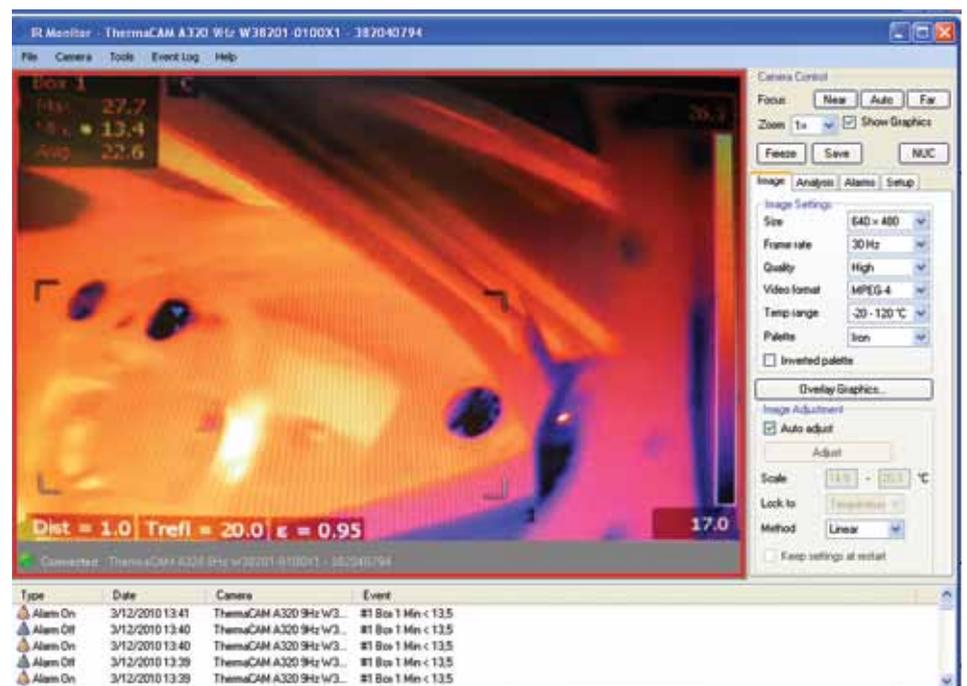
The temperature of the air coming out of the air conditioning vent that the FLIR A320 has recorded is sent to the PLC for comparison with previously determined parameters.

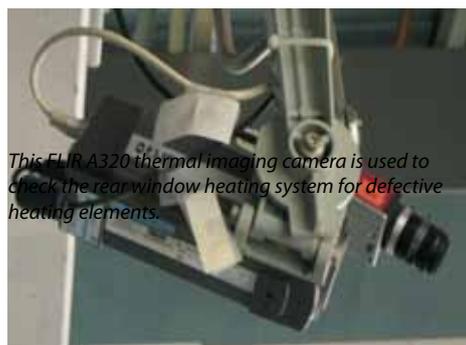
This FLIR A320 thermal imaging camera is used to check the rear window heating system for defective heating elements.

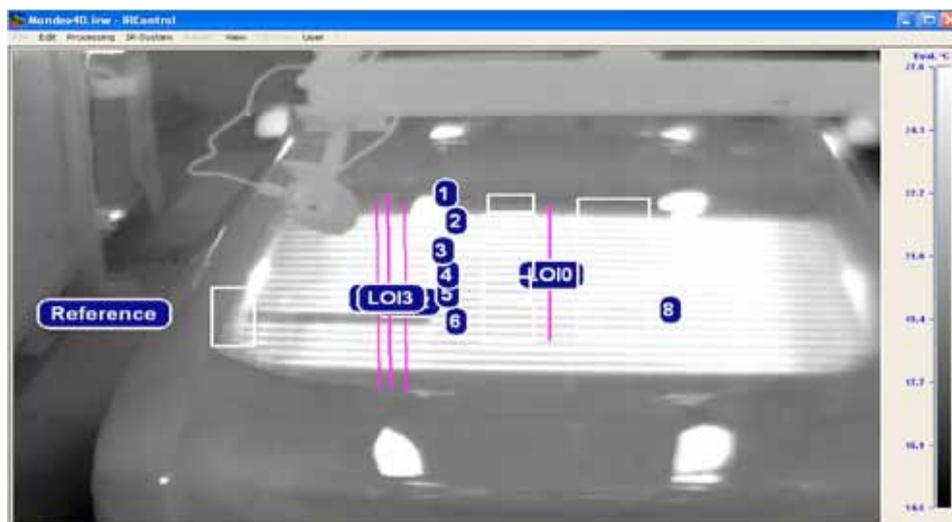
The special software tool that Rato supplied Ford Genk with compares the temperature measurements the FLIR A320 thermal imaging camera made along the purple lines.

piece of programming code that allows us to very accurately determine whether the heating elements are working." Using that tool the FLIR A320 thermal imaging camera records the temperatures along a vertical line. "If all the heating elements function normally then the resulting graph should follow the correct pattern. If one or more heating elements do not function properly then it will clearly show up on the graph", explains Knuyesen.

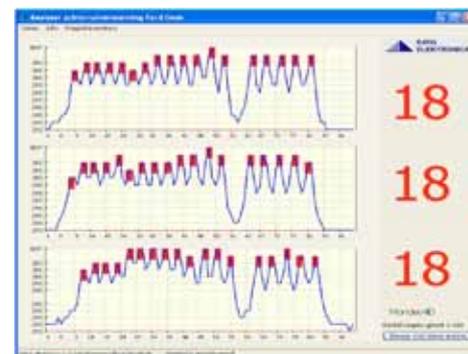
The temperature readings result in a graph that should have exactly as many peaks as the car's rear window has heating elements. If one of these peaks is missing on the graph that indicates a defective heating element.

"Before this solution was supplied by Rato we used another system with square measurement areas instead of one vertical line. We measured the temperature for each square and if one would be below a previously set value it would be recorded as defective, but the system wasn't perfect. Due to heat dispersion in the rear window sometimes a car with one defective heating element would pass the tests. With the new method this doesn't happen anymore, so we can be completely sure that the customer receives a car that has a rear window heating system with completely functional heating elements."
