MOBILE THERMOGRAPHIC MONITORING OF BELT CONVEYORS HELPS AVOID FIRES

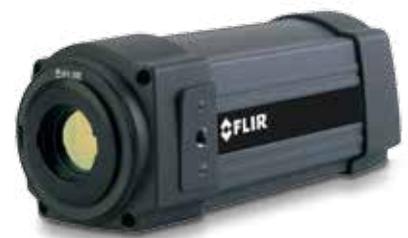
The FLIR A310 thermal imaging camera

permanently installed thermal imaging camera from the FLIR A series. The FLIR A310 was mounted on the bed of an SUV and pointed in about a 45-degree angle to the direction of travel. Among other things, a special housing unit was required to securely mount the FLIR A310. The thermographic camera system can operate without any cable connection, because it includes a battery power supply and a wireless communication unit.

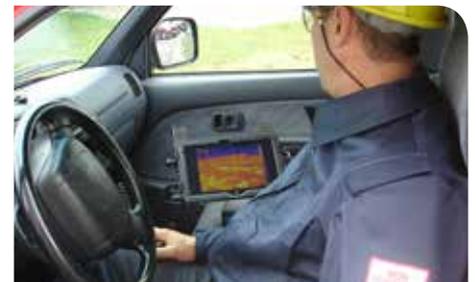
Monitoring with the tablet PC

Klaus Flocke recommended a wide-angle lens to cover as much of the conveyor belts as possible while passing by. The A310 transmits the camera image via Wi-Fi to a tablet PC installed in the driver's cab. If a preset alarm temperature is detected, this tablet PC emits an acoustic warning signal. Only then the driver (who otherwise focusses entirely on driving about 20 km/h at a distance of 2-15 meters away from the conveyor belts) checks the image on the monitor and locates the overheated section of rollers on the conveyor belts.

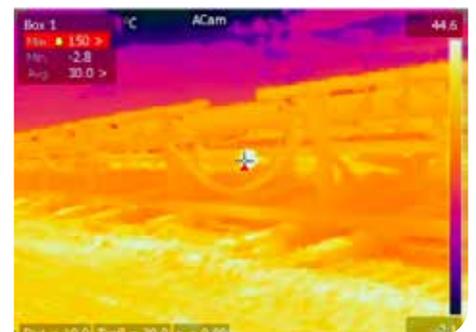
This belt conveyor has a temperature of over 150 degrees Celsius

When monitoring to prevent fires, on the other hand, the alarm threshold was set to 90°C based on IBExU (Institut für Sicherheitstechnik GmbH) recommendations pertaining to the inflammation point of rubber or polyurethane materials. All of the test drives with this alarm threshold detected only the overheated idlers as well as smouldering fires near the cross pit conveyors.

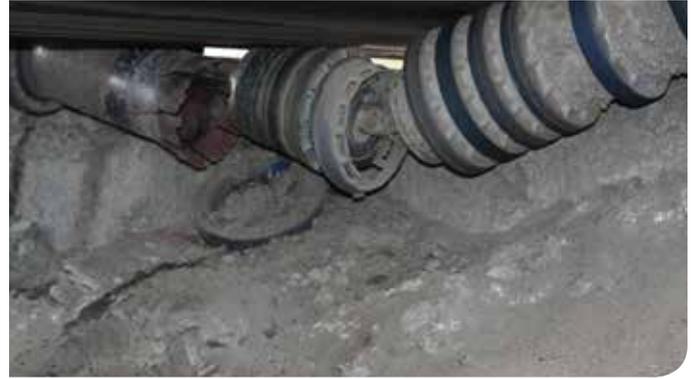
Defective lower support roller of a belt conveyor

At its strip mines, MIBRAG operates approximately 70 km of belt conveyors, which include steel rollers and idlers with rubber or polyurethane support rings. Wear on the bearings can cause overheating, which can ignite the lubricants and support rings of the lower rollers. Even the upper steel rollers can heat up to the point that the steel starts to glow. Especially when a belt conveyor is at a standstill, a large fire hazard can arise after just 10 to 15 minutes.

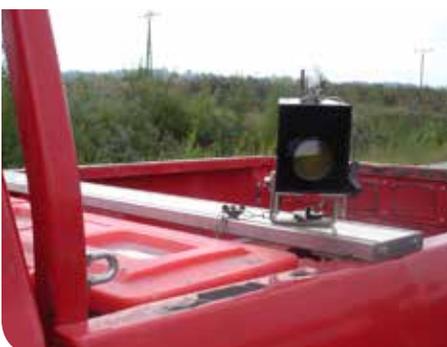
The FLIR A310 was mounted on the pick-up in a special protective housing
