Thermal imaging camera proves ideal for offshore inspection

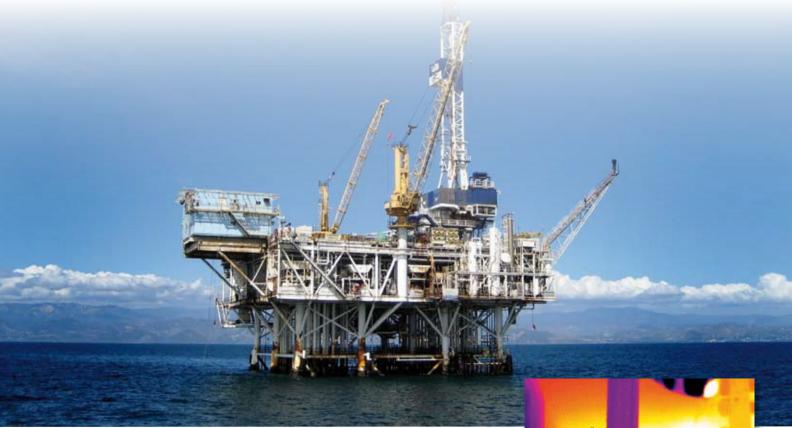
Infrared image of an oil installation.
