## 100% quality control of resistors with FLIR thermal imaging camera

*Cutting down failure rates of electronic components is essential for companies that want to supply a perfect product to their customers. The only way to ensure this is by checking each individual component to provide 100% quality control. This requirement was addressed by Isabellenhütte - a manufacturer of resistance alloys for thermocouples, alloys for extension leads and passive components used in the automotive industry - by using a thermal imaging camera system from FLIR Systems.*

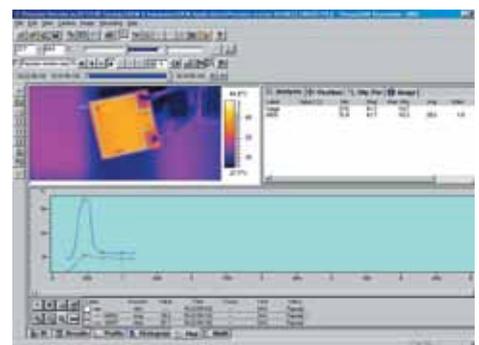
*The FLIR Systems thermal imaging camera detects even the smallest defect in a resistor.*

The solution that Isabellenhütte adopted was to install a thermal imaging camera system from FLIR Systems. This is used to inspect each component produced. Within a timeframe of less than 1 second, the system makes an infrared image that allows it to check the resistor for possible defects. These are shown as hot spots in the image, resulting from the higher surface temperature of a faulty device.

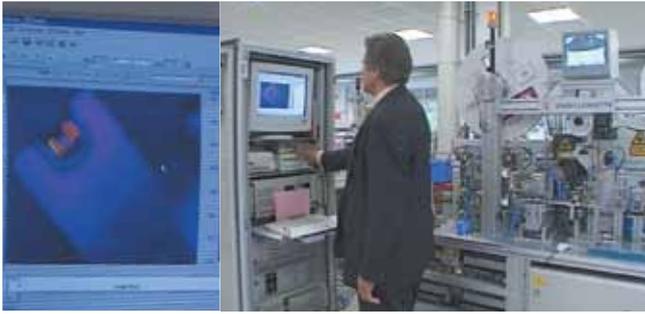
Fully automated quality control thanks to the FLIR Systems thermal imaging camera.

time. Within 20 ms the thermal imaging camera observes the thermal cycle of the component. Using the machine vision software IRCheck designed by the system integrator Automation Technology ([www.automationtechnology.de](http://www.automationtechnology.de)), the computer compares the maximum detected temperature with the average surface temperature of the resistor. If the difference between the maximum and average values exceeds a predefined value,

this means that the component has a hot spot. When a hot spot is detected a trigger signal is automatically generated to remove the faulty component from the production line. The whole process takes less than 1 second, from the entry to the exit of the testing machine. The thermal image with the defective area on the component is stored in a database for statistical process control purposes.

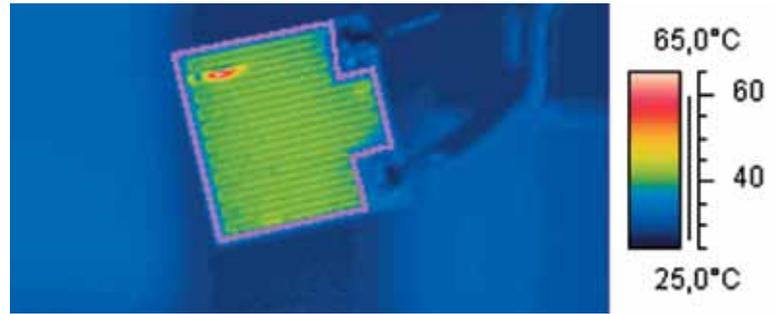
A flawed resistor controlled with a thermal imaging camera

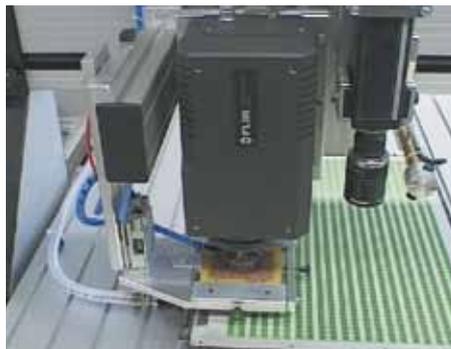
Each component is individually inspected by the FLIR thermal imaging camera.

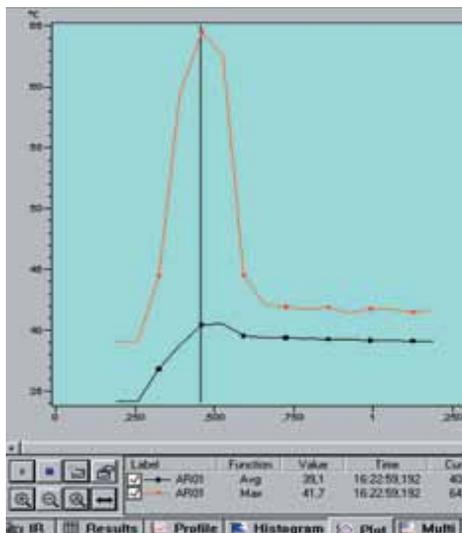
The time trend analysis of the maximum and average temperatures of a faulty component, using the specially developed machine vision software.

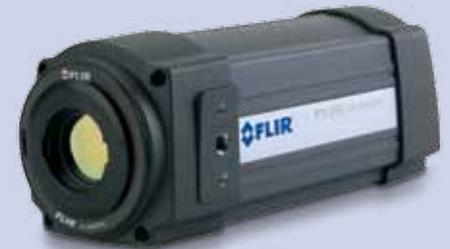
### FLIR A310

The thermal imaging camera used for this application is the ThermoVision™ A320M. This model has been replaced by the even better performing FLIR A310

The FLIR A310 is a compact fixed mounted camera that can be installed almost anywhere. It can measure temperature differences as small as 0.05 °C. Exclusive measurement analysis function and alarm functions make the FLIR A310 the perfect tool for many applications.
